CIELITO DE LINDO TUBAC HOA

Level 2 Reserve Study Update (With Site-Visit)

Prepared For Fiscal Year 2024

March 17, 2024

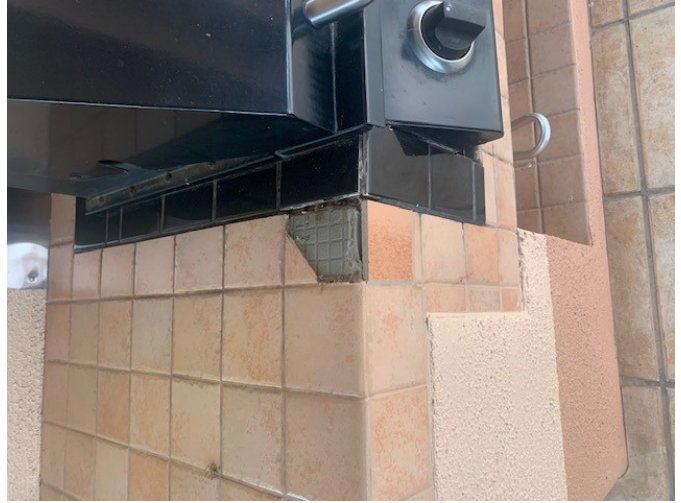
Tile missing at countertop.

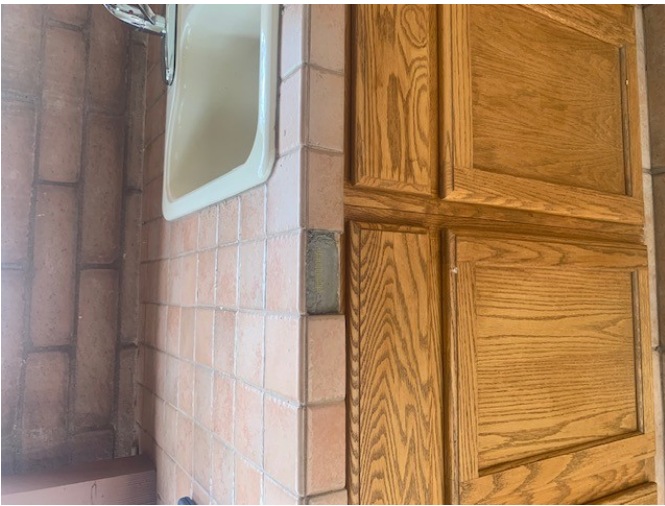
Tile missing at countertop.

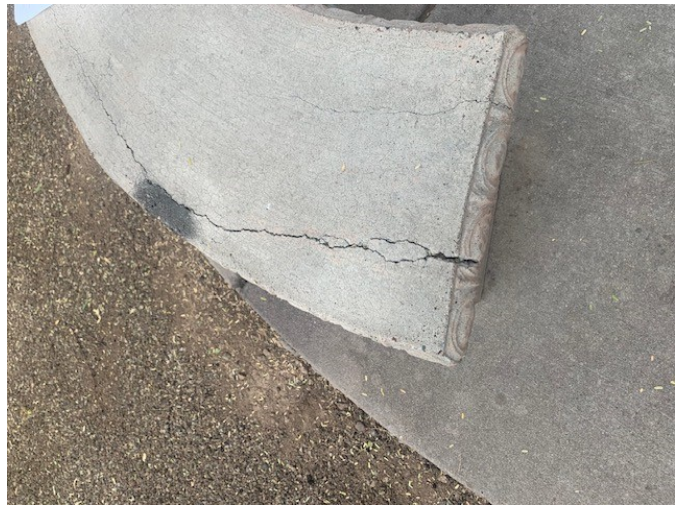
Concrete bench deterioration/crack observed.

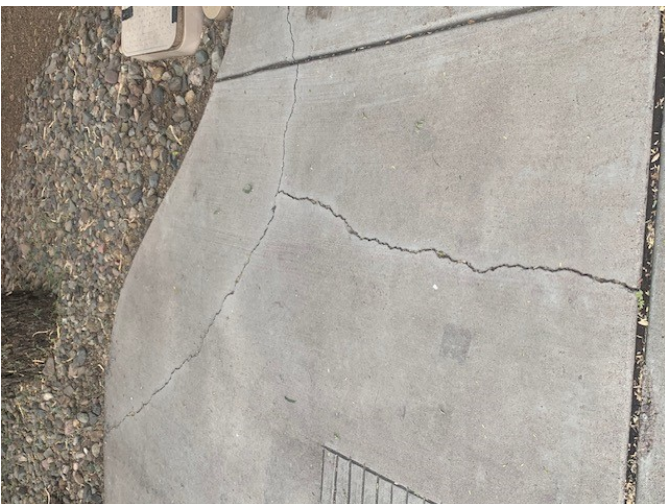
Isolated pavement cracks.

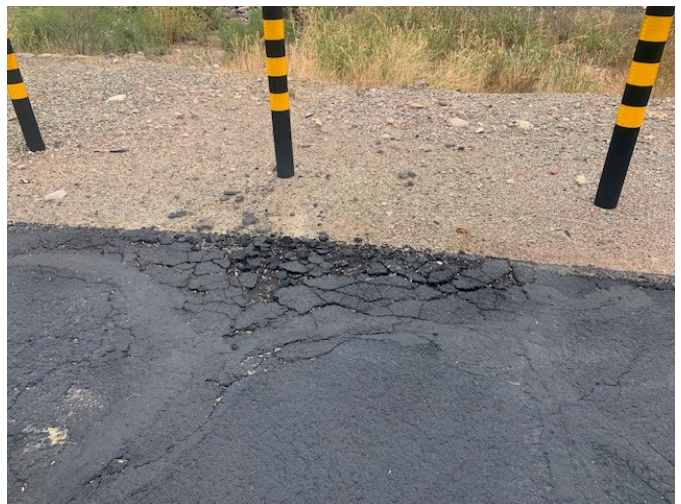
Isolated areas of deteriorated pavement.
